## **WATERFORD ASSOCIATION, INC. RESERVE STUDY**

**For 30-Year Projection Period: FY 2026 through FY 2056**

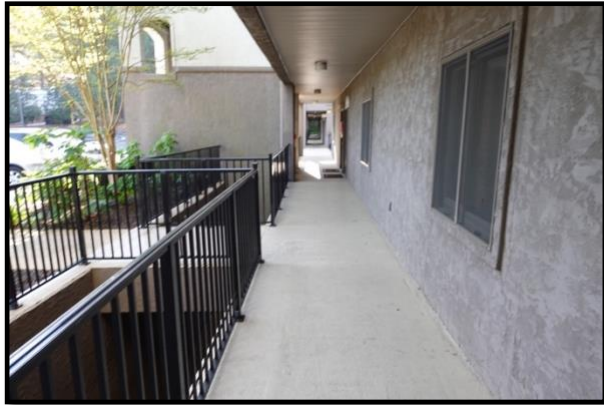
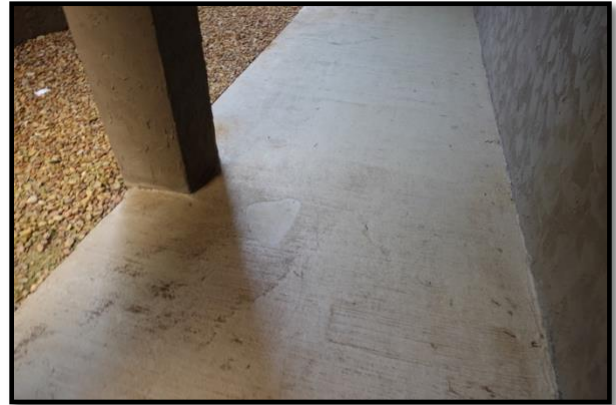
Waterford maintains breezeways that comprise approximately 9,095 square feet of concrete surface. The breezeways are in fair condition overall. Breezeways have a long useful life with the benefit of periodic maintenance. Concrete cracks and spalling occur from the expansion of the reinforcing steel bars due to corrosion. Concrete corrosion is caused by rainwater and chlorides penetrating the surface of the concrete and contacting the embedded steel reinforcement bars. Failure to maintain the breezeways can lead to costly repairs.

Figure 1 – Elevated Breezeway

Figure 2 – On Grade Breezeway

Concrete repairs include replacing compromised reinforcing within associated cracks and spalls. Cracks should be repaired with a gravity feed epoxy. Waterford should consider using a hybrid coating consisting of a urethane base coat with a textured acrylic topcoat. The proper way to apply coatings is to remove and reinstall the railings. Coatings provide the primary protection from the elements and can minimize ongoing cyclic structural concrete damage (spalling) due to corrosion. Waterproof coatings applied to horizontal walking surfaces should meet or exceed the minimum requirements for pedestrian traffic bearing capacity and slip resistance.

The Association shall budget for waterproof coating applications, cant bead and partial repairs as needed by 2029 and every 5- to 10-years thereafter. The cant bead is the seal between

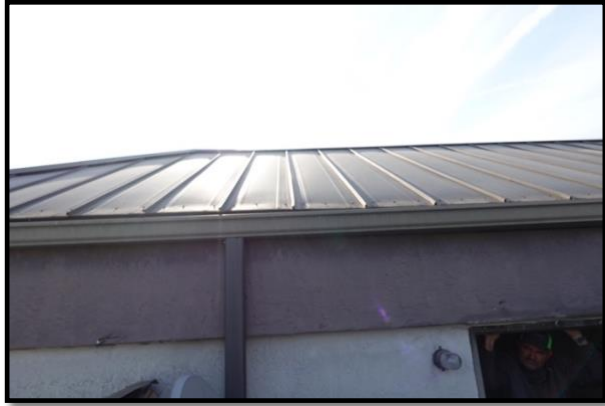
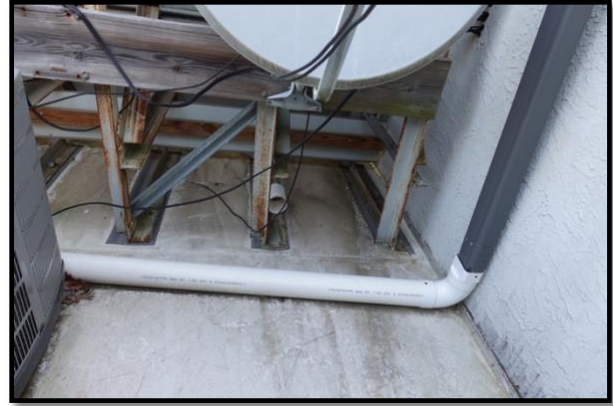
Waterford utilizes approximately 2,825 linear feet of gutters and downspouts that are designed to collect rainwater from the roofs and shed the water away from the buildings. Management reports that the Association replaced 825 linear in 2023 and plans to replace the remaining gutters and downspouts in 2026 funded through a special assessment. Gutters and downspouts have an estimated useful life of up to 20 years. The Association should budget for phased replacements beginning by 2043 and concluding by 2046. The Association should utilize downspout extensions and splash blocks at discharge areas to direct the water away from foundations.

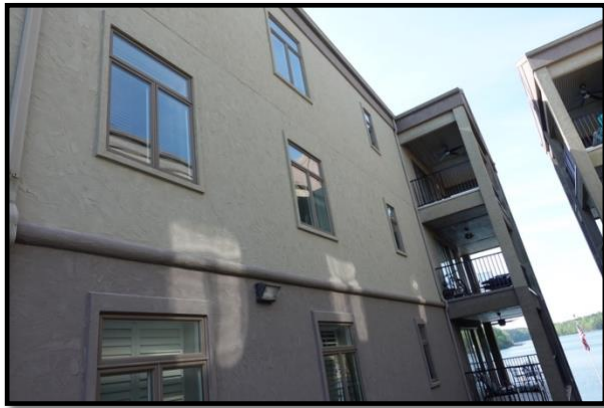
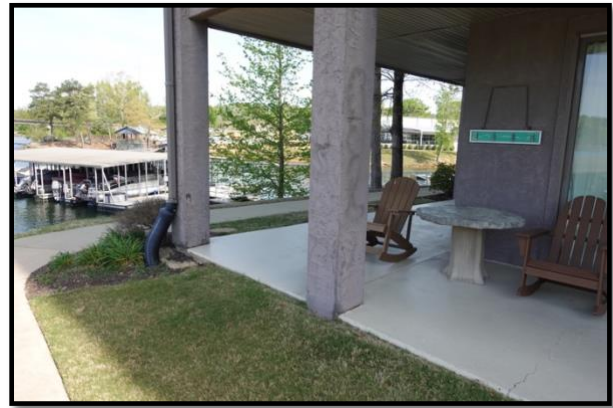
Exterior Insulation and Finish System (EIFS) is a multi-layered exterior wall cladding system commonly used in residential and commercial construction throughout Alabama due to its energy efficiency and design flexibility. EIFS typically consists of an insulation board mechanically fastened or adhesively applied to the substrate, a base coat with embedded reinforcing mesh, and a textured finish coat that provides weather resistance and aesthetic appeal. While EIFS offers advantages such as improved thermal performance and moisture resistance when properly installed, it is also a system that requires careful inspection and ongoing maintenance to ensure long-term performance.

EIFS should be evaluated for signs of distress including cracking, delamination, impact damage, sealant failure at joints and penetrations, and evidence of moisture intrusion. Alabama's hot, humid climate and frequent rainfall increase the importance of proper sealing and drainage, as trapped moisture can lead to substrate deterioration, mold growth, and structural damage. Attention should be given to areas around windows, doors, balconies, and other penetrations where failures are most likely to occur.

It is recommended that associations implement a proactive maintenance program that includes regular visual inspections and, when warranted, invasive moisture testing to identify concealed issues. Given the potential for hidden damage and the cost associated with repairs, adequate reserves are essential to address both anticipated maintenance and unforeseen corrective work. Management reports that the Association plans to remove and replace the EIFS in 2026 funded through a special assessment. Waterford should budget for a subsequent renovation by 2056. The estimate of costs includes the retaining walls.

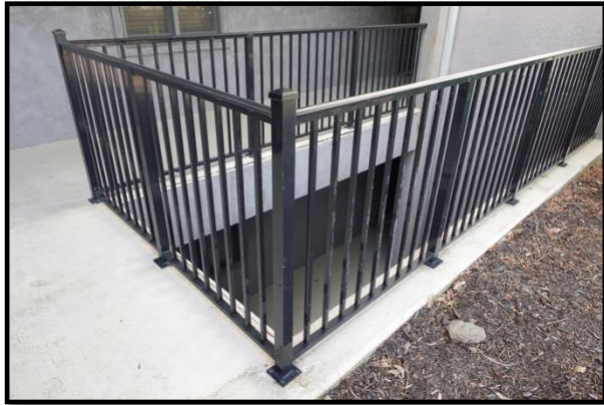
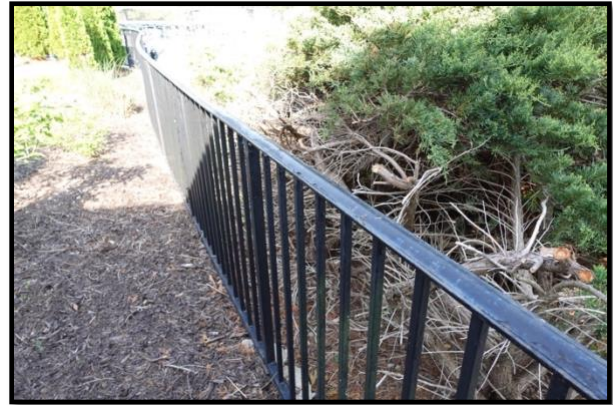
The Association maintains 2,145 and 895 linear feet of aluminum and metal railings respectively. Management reports that Waterford plans to replace most of the metal railings in 2026 funded through a special assessment. The finish on aluminum fences is relatively maintenance free. While aluminum doesn't rust, it does corrode over time. Improper railing coatings along the coast can be problematic. Powder coating systems are known to experience corrosion which causes peeling. Semi-crystalline thermoplastic fluoropolymer (PVDF) aka Kynar utilizes a preferred chromium pretreatment process to provide excellent adhesion and weathering. Aluminum railings have a useful life of up to 30 years. The major concern with railings is safety. Waterford can maximize the useful life by repairing connections and fasteners promptly when and if they fail. These activities should be funded through the operating budget on an as needed basis.

Figure 1 - Aluminum

Figure 2 - Metal

The Association shall budget for replacement of the existing aluminum railings by 2051 followed by the remaining railings by 2056.

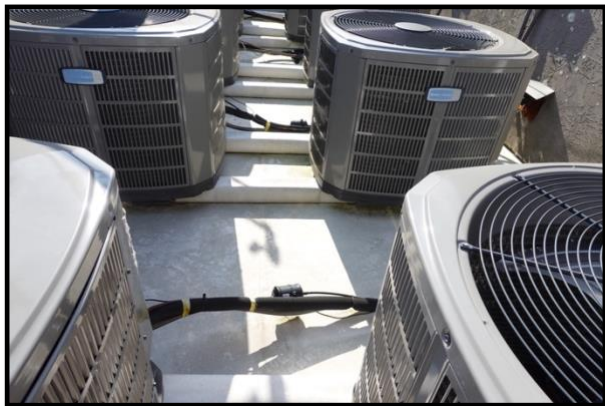
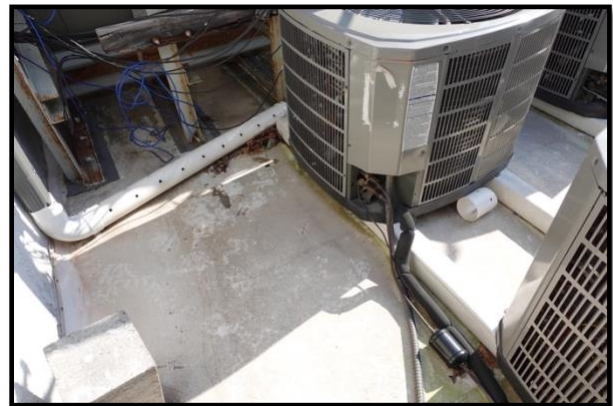
The Association maintains 15 squares of flat roofs. The flat roofs are in good condition at an age of three years. Flat roof coverings have a useful life of up to 25 years.

The Association should budget for replacements of the flat roof system by 2048. The Association should look for roof system warranties offered by manufacturers. No Dollar Limit (NDL) warranties include roof leaks caused by defects in labor or materials. Interim annual inspections should be funded through the operating budget to preserve the warranty. It is assumed that the roof was not overlaid and the estimate of cost is based on tearing off one roof only.

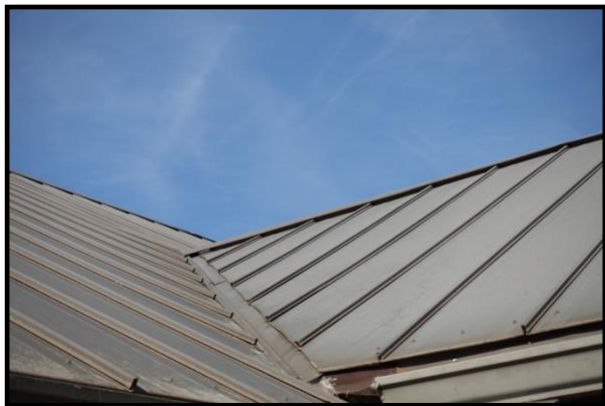
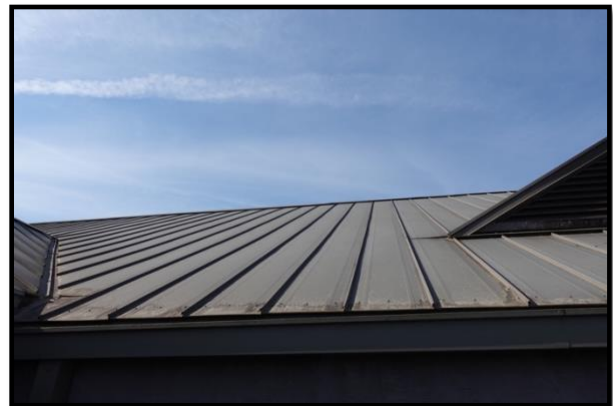
There are also approximately 260 squares of standing seam metal roofs. Roof panels are crimped together rather than fastened by screws. The metal roofs are in fair overall condition at an age of 19 years. Metal roofs of this type have a useful life of up to 35 years. The Association should budget for replacement of the metal roofs by 2042.

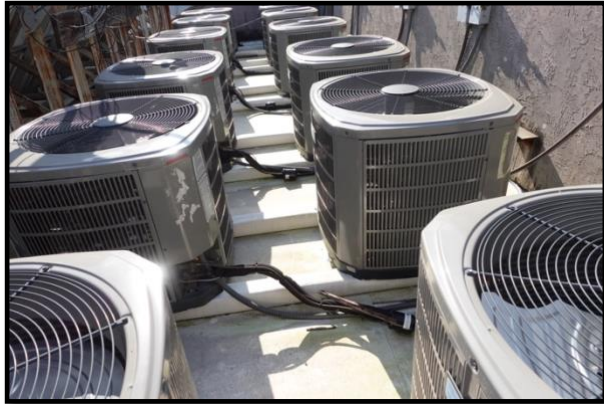
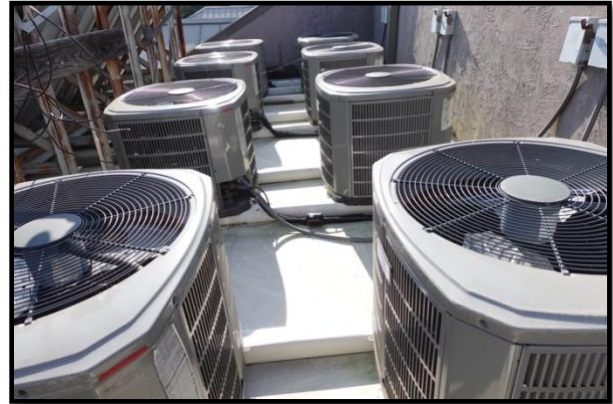
The Association is responsible for the shared HVAC rooftop stands. These stands are in good condition at an age of three years. The process of replacing a stand typically includes disconnecting the electrical service, coolant supply line, condenser removal including hurricane straps and vibration pads. New stands have an anticipated an estimated useful life of up to 25 years. Waterford should budget for replacements by 2048.

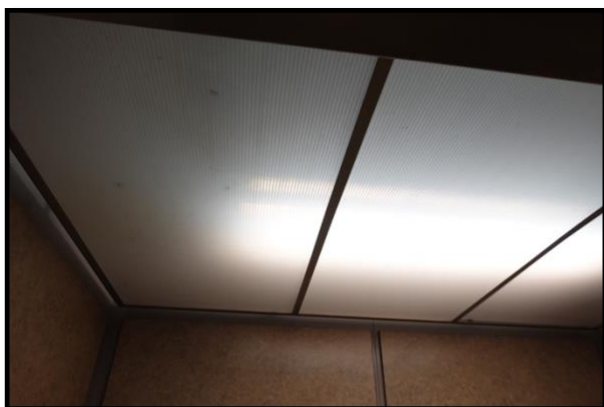
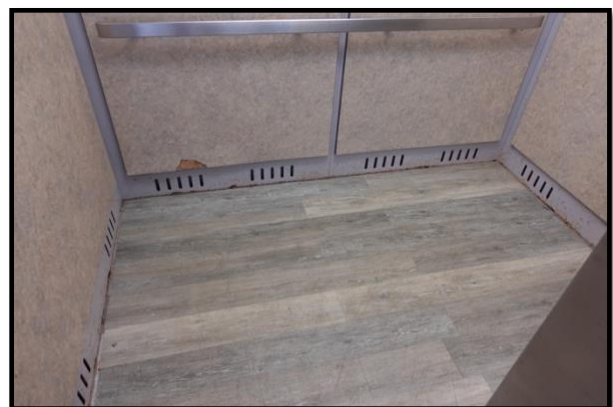
The Association maintains two elevators. The cab finishes comprise resilient floors, lighted ceiling and wood panel walls. The cab finishes are in fair overall condition at an age of 19 years. The timing of renovations is discretionary. The Association should budget for replacements in 2027 and again by 2047.

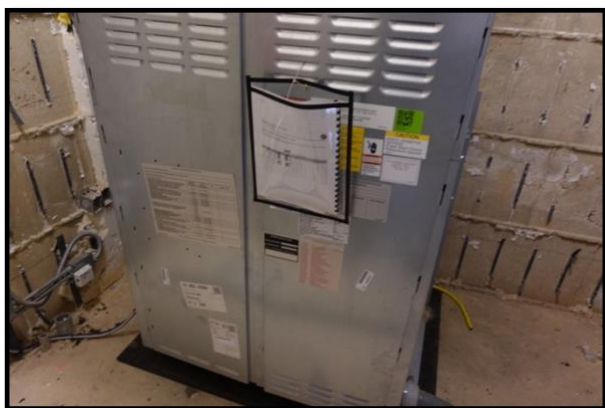
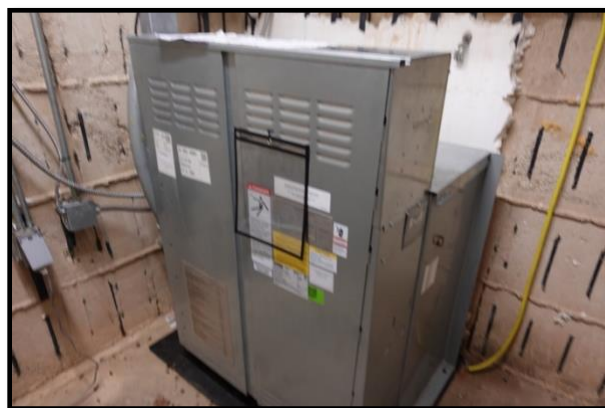
The Association utilizes two 2,000-pound capacity hydraulic elevators to serve four floors. Hydraulic elevator components include a cylinder, pump and controls. Management reports that Waterford modernized the elevators in the last couple years. The useful lives of these components vary up to 30 years. However, factors such as design, usage, environmental, and maintenance frequency will increase or decrease lifecycle. The Association should budget for the next modernization by 2054.

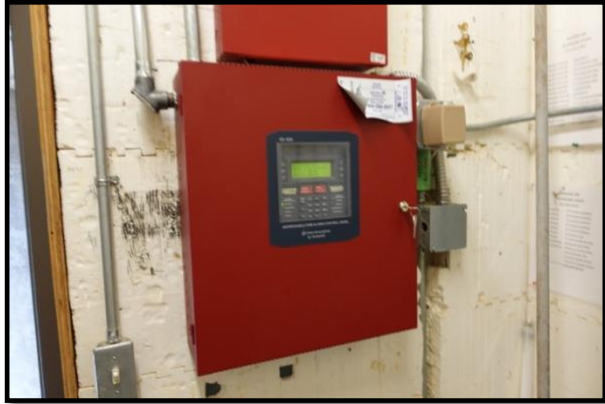
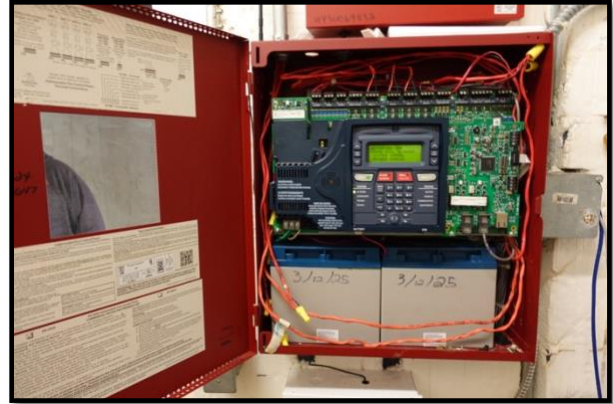
The Association maintains a fire protection system for each building. These fire protection systems comprise a main panel that controls emergency devices such as annunciators and pull boxes, piping and sprinkler heads located throughout the buildings. The alarm system utilizes a battery backup. The fire protection systems are in satisfactory operational condition. Changes in building codes and/or technology may make a replacement necessary and/or desirable prior to the useful life of up to 25 years. Waterford shall budget for replacement of the fire alarm system by 2032. The Association should fund interim replacement of exit signs and sprinkler heads through the operating budget as needed.

Annual fire protection system inspections are required by the National Fire Protection Association (NFPA) 722 Standards. It is recommended that Association consult local fire departments to ensure there are adequate safety provisions in place.

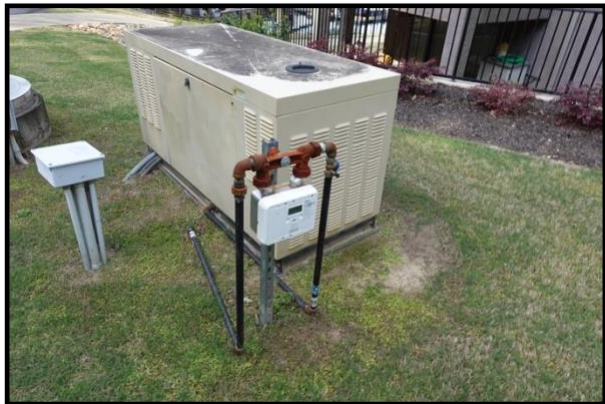
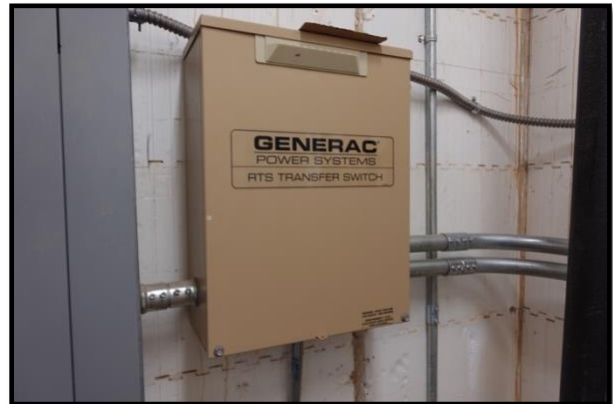
Waterford utilizes a propane generator to power the lift station and common lights during a power outage. The generator is original and in satisfactory operational condition. Generators have a useful life from 25- to 35-years. The Association should budget for replacement by 2042. Generator transfer switches have a shorter useful life. The Association should fund replacement of the transfer switch and batteries through the operating budget as needed. The system should be inspected and maintained quarterly.

Figure 2 – Transfer Switch

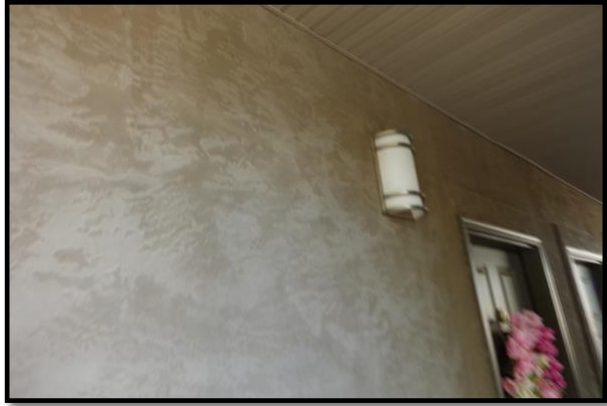
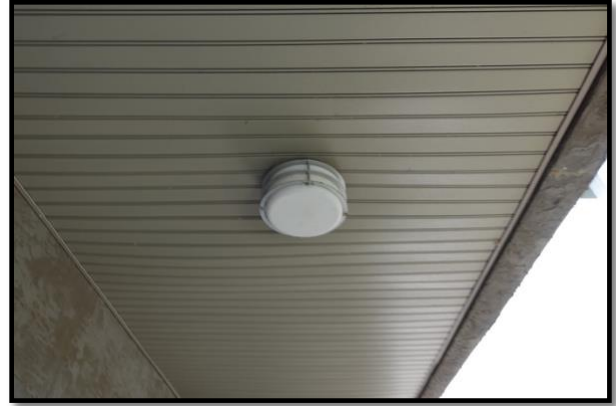
The Association maintains 144 exterior wall and ceiling mounted light fixtures. The light fixtures are in fair condition at an age of 19 years. Light fixtures have an estimated useful life of up to 20 years. Waterford should budget for replacement of the light fixtures by 2027.

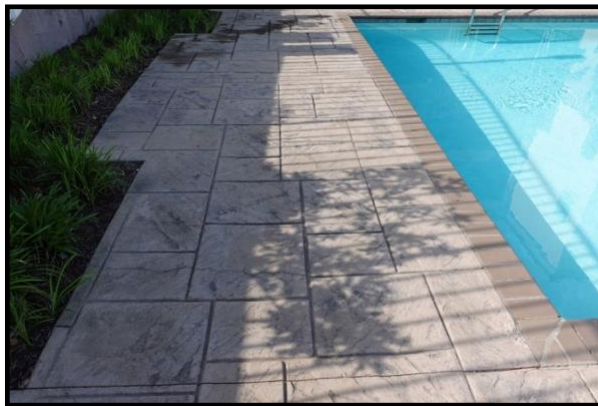
Figure 1

The pool deck comprises 2,690 square feet of concrete. The pool deck is original, and the coating is in fair overall condition at an age of approximately five years. Concrete pool decks have a long useful life with the benefit of periodic maintenance. Periodic maintenance includes a slip resistant coating application every 5- to 10-years. Based on the condition, Waterford should budget for the next coating application by 2028 and every seven years thereafter.

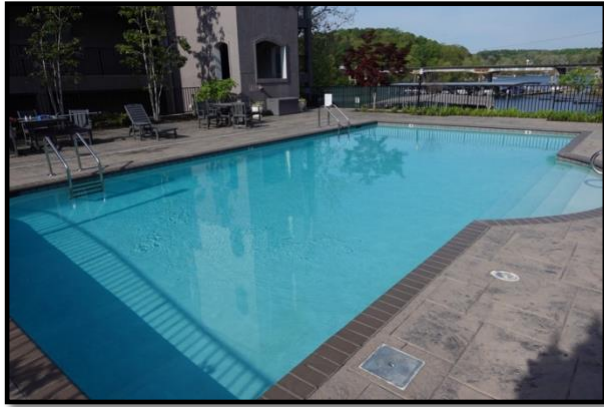
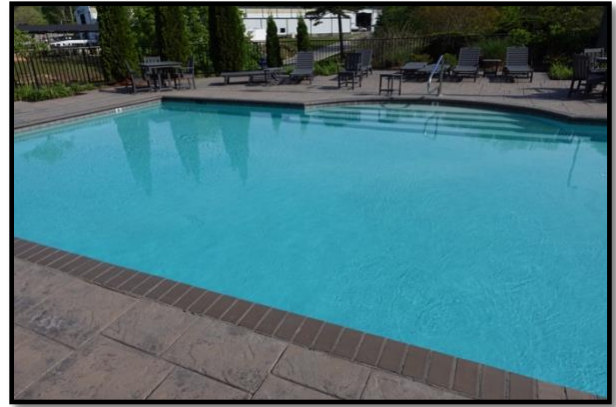
The Gunite finish at the pool wall and floor surfaces is in good overall condition at an age of four years. Pool finishes have an anticipated useful life from 10- to 15-years. The Association should budget for resurfacing of the wall and floor areas, as well as replacement of the pool waterline tile, by 2034 and again by 2046. Typically, minor upgrades will be needed to bring the

pool up to current code. Potential repairs to the underlying pool structure may raise the estimate of cost.

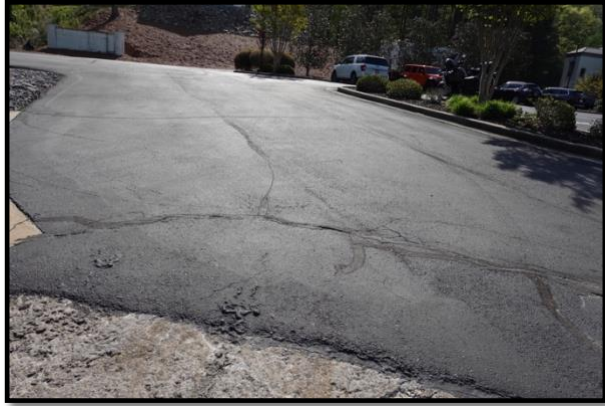
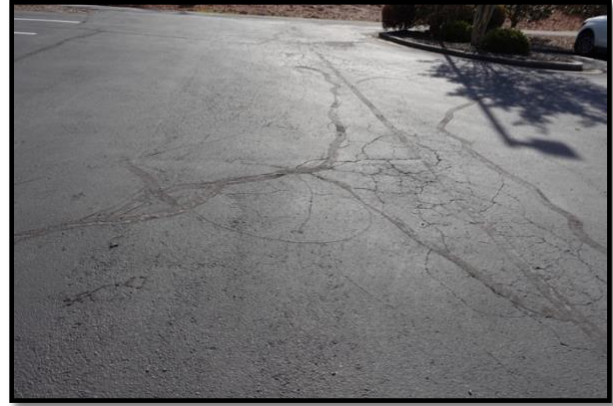
Pavement surfaces comprise aggregate in an asphalt/petroleum binder. The petroleum elements of the binder oxidize, and the asphalt loses its elastic properties over time and becomes brittle and then cracks occur. One form of pavement maintenance is a process called rejuvenation. Rejuvenation is intended to prolong the aging process by adding back the petroleum fractions needed for elasticity of the surface course.

Proposals for asphalt coating applications should include both crack seal repair and area patching. These activities reduce water infiltration and the effects of weather. The contractor should only apply asphalt coating applications after crack and surface repairs are completed.

Waterford should plan for an application of pavement preservation by 2035 following repaving. Subsequent cycles are likely every five- to eight-years thereafter except when replacement occurs.

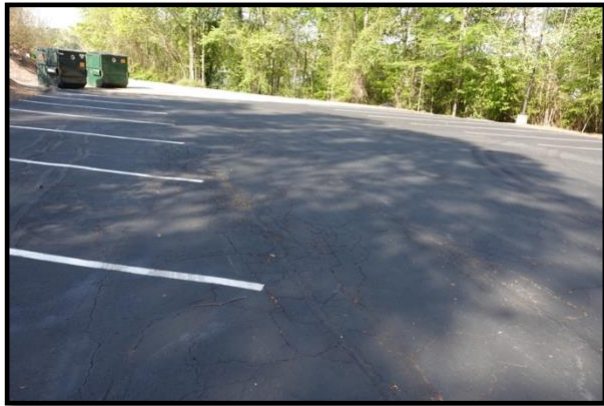
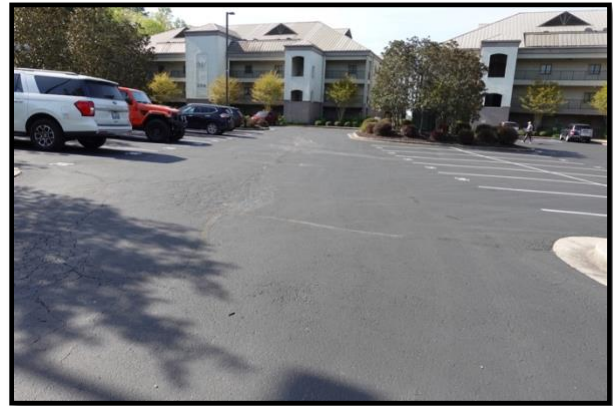
As previously mentioned, the Association maintains approximately 4,725 square yards of asphalt pavement. The asphalt pavement is original and in fair overall condition. Areas of cracks are noted. Asphalt pavement comprises multiple layers. Typically, the top layer or surface course deteriorates over time and can be milled or removed and overlaid or replaced. The following diagram depicts typical pavement layers.

A combination of area patching, crack repair and milling should occur before the overlayment. Areas that exhibit potholes, alligator cracks and areas of pavement that are deteriorated from vehicle fluids should all be repaired prior to overlayment. Area patching may

The estimated useful life of the asphalt pavement surface course varies from 15- to 30-years due to design, quality of construction, materials and maintenance. Waterford should budget for a mill and overlay of the pavement by 2030 and again by 2055. The Association should retain an engineer for quality control.

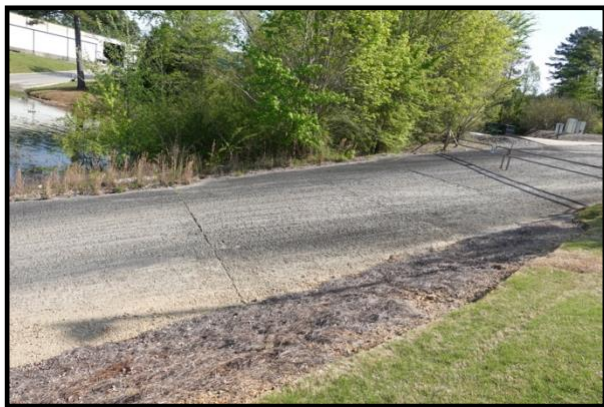
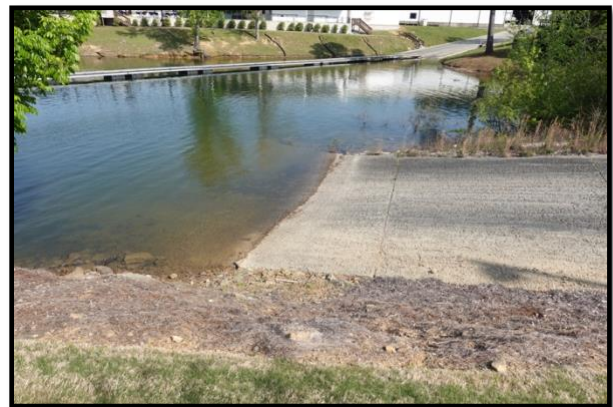
The Association maintains a boat ramp. The boat ramp is in fair overall condition. The exact age is unknown. A boat ramp has an estimated useful life of up to 30 years. For budgetary purposes, Waterford should plan for replacement of the boat ramp by 2031.

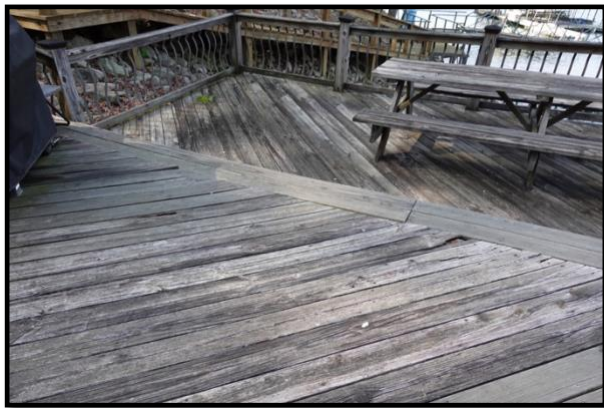
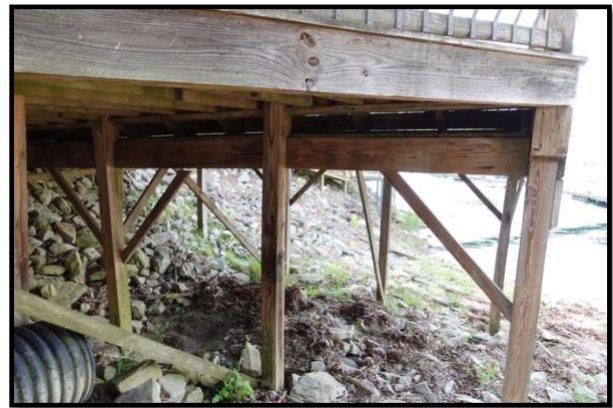
The Association maintains approximately 450 square feet of a wood deck. The decking is original and in poor overall condition. The estimated useful life of this type of decking is from 15- to 20-years. Waterford should budget for replacement in 2026 and again by 2046. The Association should consider replacing the rails and decking with a composite material. The costs are comparable. Composite requires little maintenance. The Association should fund cleaning, partial repairs and or replacements through the operating budget on an as needed basis to maximize the useful life. Repairs may include replacement of warped or loose deck boards or railing components, replacement or additional installation of connections or fasteners, and partial replacements of structural members as needed.

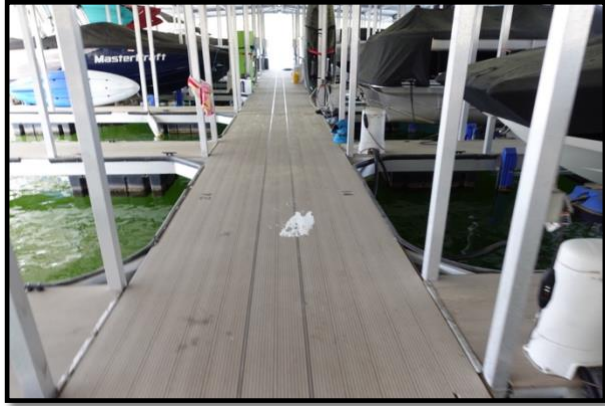
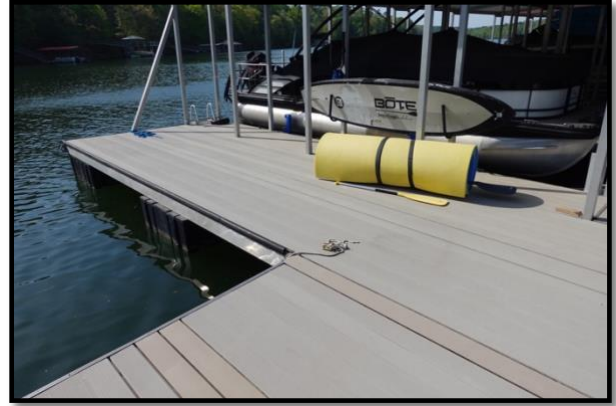
The decking is in fair condition at the time of observation. The surface appears generally uniform with no significant warping, cracking, or displacement observed. Board alignment is consistent, and there are no obvious trip hazards. Minor surface wear consistent with normal use and environmental exposure is noted. Fastening systems are not fully visible but the decking appears secure.

- Routine cleaning to prevent algae buildup and maintain slip resistance
- Periodic inspection of:
  - Fasteners and connection points
  - Board integrity (cracking, splitting, or excessive fading)
- Replacement of individual damaged boards as needed
- Monitoring for movement or separation at joints

The composite decking has an estimated useful life from 20- to 25-years, resulting in a projected replacement year of 2034.

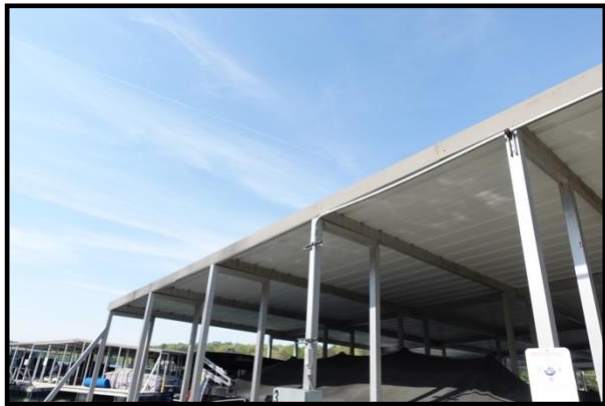
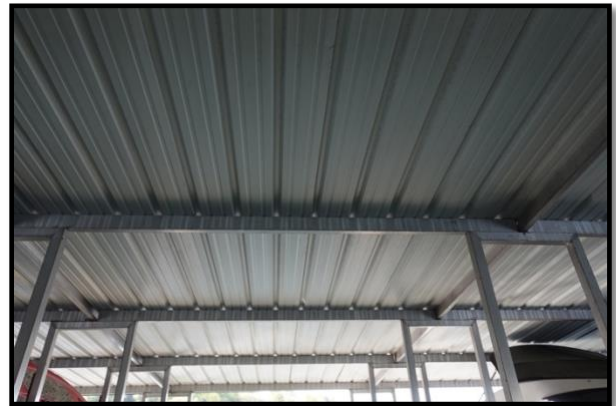
The Association maintains roofs that cover 19,315 square feet. The roofs are in fair condition overall at an age of 15 years. The Association should keep the roofs clean and free of debris. These roofs have an estimated useful life from 30- to 40-years. Waterford should budget for replacement of the dock roofs by 2046. The Association should fund repairs to the roofs, including paint finish applications, replacement of damaged sections or columns, and repairs to connections and/or fasteners, through the operating budget as needed.

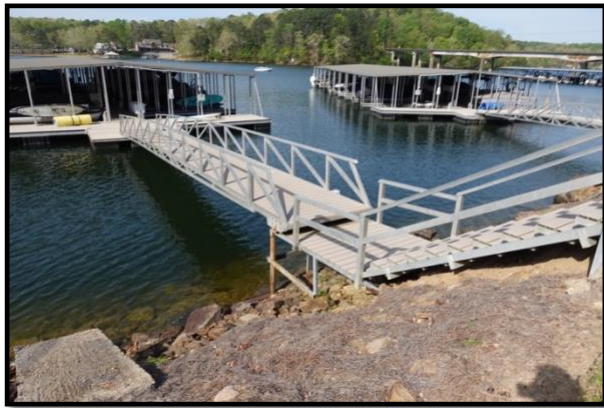
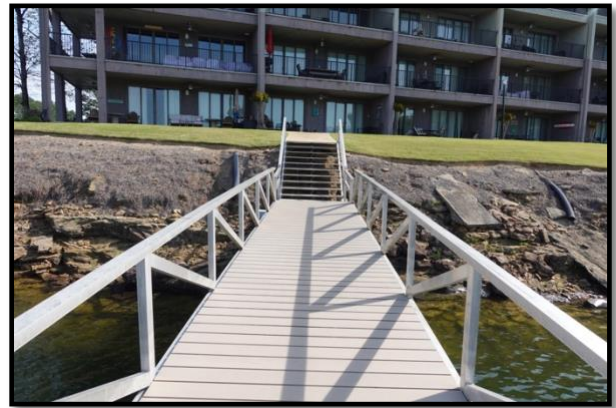
The gangway is in good condition overall at the time of observation. The aluminum framing appears structurally sound with no visible distortion or significant corrosion. Handrails are intact and secure. The walking surface appears even and functional with no apparent safety hazards. Connection points at both ends appear serviceable; however, these areas are subject to ongoing wear due to movement and environmental exposure. The Association should budget for replacements by 2036.

- Annual inspection of hinges, pivot points, and anchoring connections
- Tightening or replacement of fasteners as needed
- Monitoring for corrosion, particularly at joints and dissimilar metal interfaces
- Cleaning of walking surface to maintain slip resistance

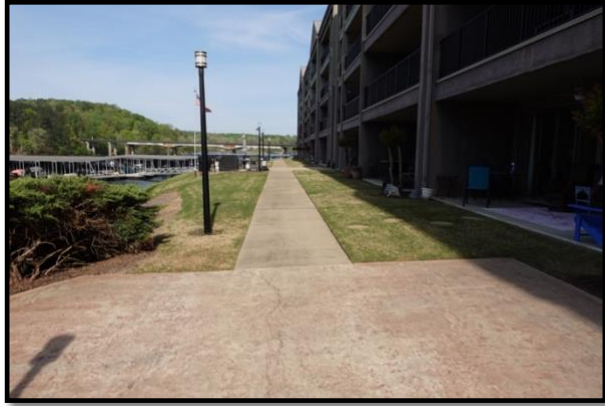
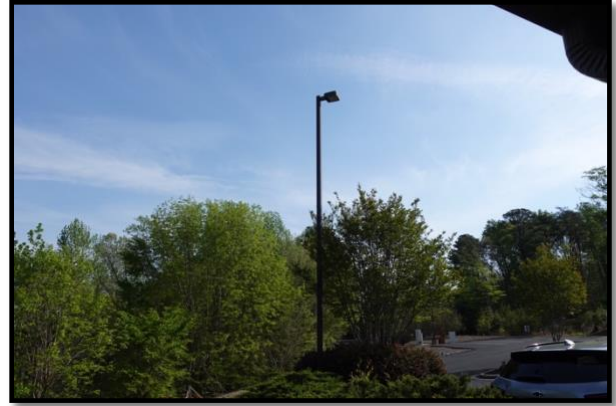
The Association maintains the 23 light poles and fixtures throughout the community. The light poles and fixtures are original and in satisfactory operation condition. These light poles and fixtures have an estimated useful life of up to 30 years. Waterford should budget for replacement of the light poles and fixtures by 2037. The cost includes an allowance for replacement of the pole, base, fixture and minor electrical repairs at the time of replacement. Interim replacement of light bulbs and/or fixtures should be funded through the operating budget on an as needed basis.

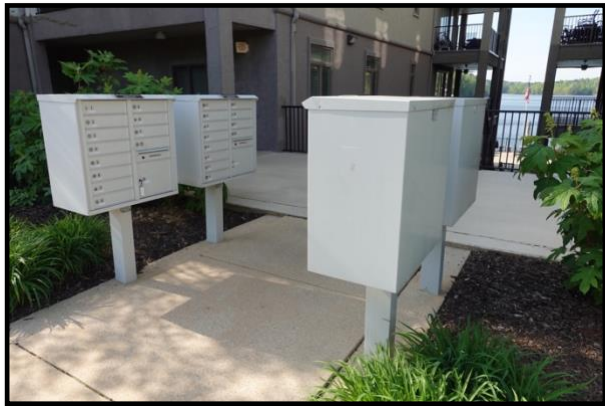
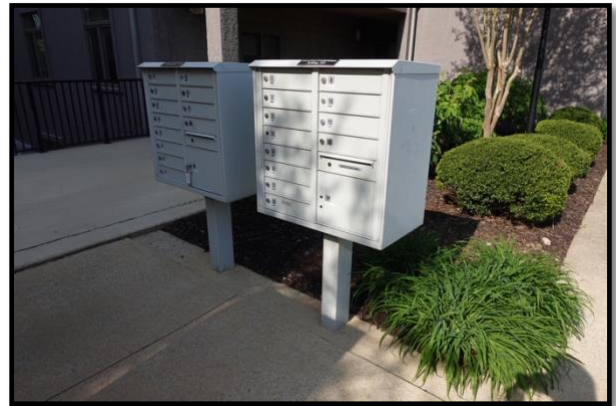
Waterford maintains four mailbox stations. The mailboxes are in fair condition at an age of 19 years. Metal mailboxes have an estimated useful life of up to 30 years. The Association should budget for replacements by 2037. The Association should verify new mailboxes meet the specifications of the United States Postal Service.

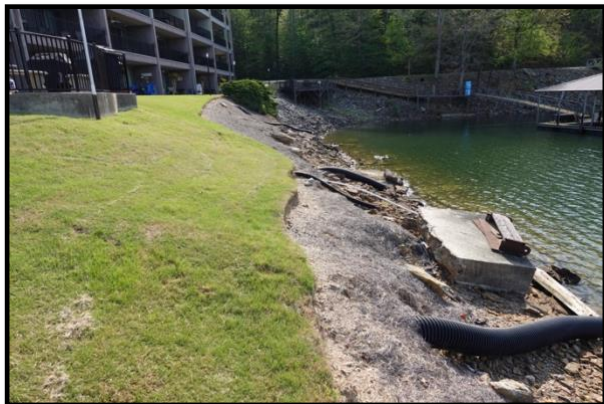
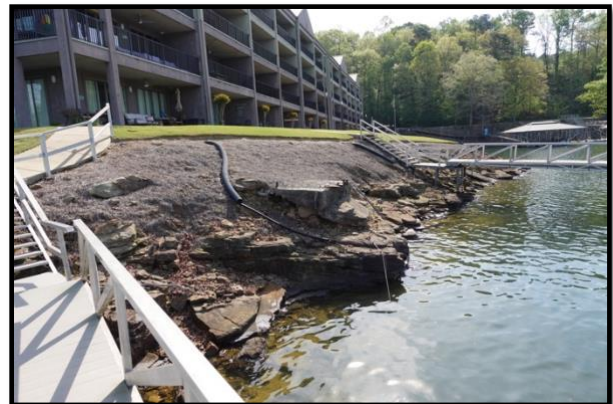
The shoreline exhibits clear signs of active erosion and bank instability. The slope is steep and largely unprotected, with exposed soils, undercut edges, and evidence of soil sloughing into the adjacent waterbody. Vegetative cover is sparse to absent along the immediate shoreline, reducing root reinforcement and increasing susceptibility to wave action and surface runoff. The presence of exposed utilities (e.g., drainage pipe) and adjacent infrastructure, including walkways and building foundations, further highlights the risk of continued erosion leading to structural impacts.

Drainage improvements should also be incorporated to manage stormwater runoff currently contributing to erosion. This may include redirecting concentrated flows through stabilized conveyances such as vegetated swales or rock-lined channels to reduce direct discharge onto the slope.

This combined approach will reduce erosive forces, stabilize the shoreline, protect adjacent infrastructure, and restore a more natural and resilient edge condition. Continued monitoring and maintenance, particularly during the vegetation establishment period, will be necessary to ensure long-term success. Waterford should conduct this project in the near term.
