## **WATERFORD ASSOCIATION, INC. RESERVE STUDY**

**For 30-Year Projection Period: FY 2026 through FY 2056**

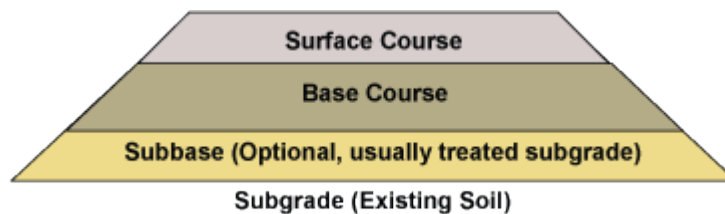
As previously mentioned, the Association maintains approximately 4,725 square yards of asphalt pavement. The asphalt pavement is original and in fair overall condition. Areas of cracks are noted. Asphalt pavement comprises multiple layers. Typically, the top layer or surface course deteriorates over time and can be milled or removed and overlaid or replaced. The following diagram depicts typical pavement layers.

A mill and overlay is a method of repaving of the surface course where cracked, worn and failed pavement is mechanically removed or milled. A new layer of asphalt is overlaid atop the remaining sound pavement. Milled pavement removes part of the existing pavement and permits the overlay to match the elevation of areas such as adjacent curbs and gutters. The milled pavement should be properly bonded to the new overlayment. Overlayment thicknesses range from one to two inches. Variable thicknesses are often necessary for proper drainage.

A combination of area patching, crack repair and milling should occur before the overlayment. Areas that exhibit potholes, alligator cracks and areas of pavement that are deteriorated from vehicle fluids should all be repaired prior to overlayment. Area patching may
